INDUSTRIAL CASE STUDY

PRISON SHOWER ROOMS

PROJECT OVERVIEW: Waterproofing prison shower rooms

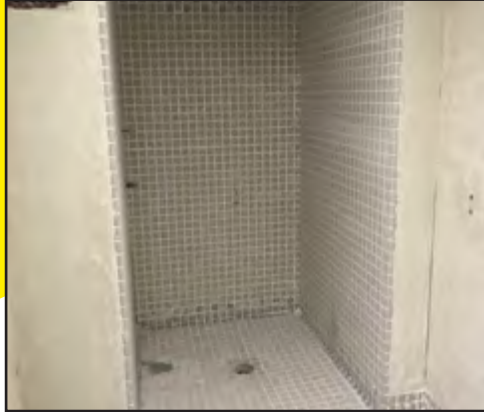
After years of consistent use, prison showers built in the 1970s had developed severe leaks.

Multiple retrofit coatings had been trailed and failed. Water was making its way through the tiles, causing drips through the ceiling on the lower floor. The prison needed a long-lasting solution to prevent further damage caused by the consistent leaks.
