LIGHT INDUSTRIAL CASE STUDY

TRUCK INTERIOR

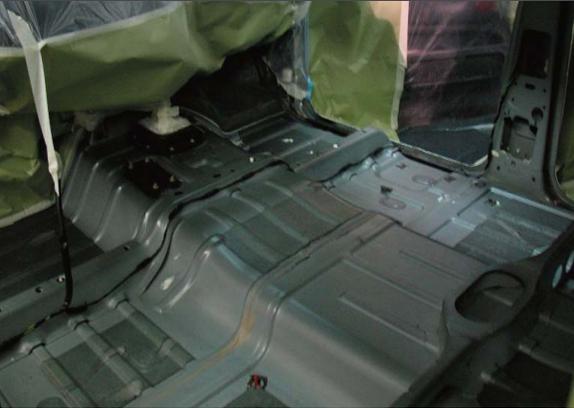
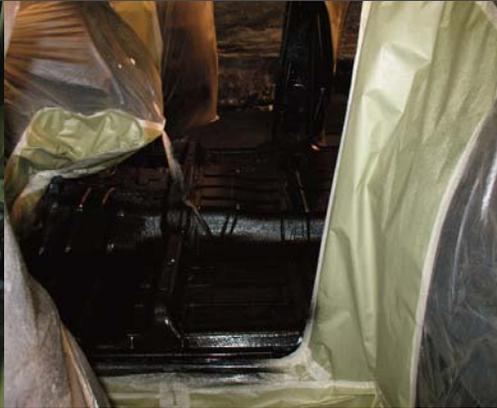
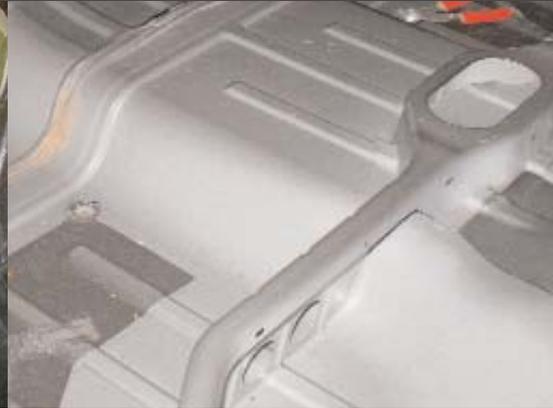
The truck was brought to the local LINE-X shop with no prep work done. LINE-X removed all interior items including seats, carpeting, center console, roof fabric and seatbelts. The dash was not removed. The metal surface beneath was cleaned, etched with 80 grit sandpaper and cleaned again. LINE-X XS-100 was used to coat the floor and rear wall at 90 mils, and the roof at

60 mils. The doors were not sprayed with LINE-X.

LINE-X XS-100 is applied directly to the metal of the interior of the truck cab underneath the carpeting, seats and other interior items. The interior items were then replaced over the LINE-X. This process allows the vehicle to retain the original look of the interior while providing a much quieter ride.
