# INDUSTRIAL CASE STUDY

## HEAVY EQUIPMENT FUEL TANK

**PROJECT OVERVIEW:** Construction/Mining/Heavy Equipment

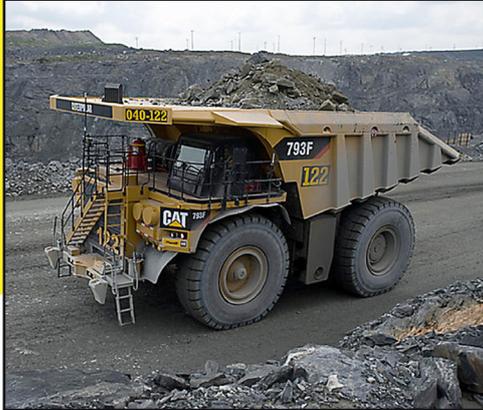
Exposure to extreme environments, weather, dangerous terrain: these are all challenges that heavy machinery must overcome working in large scale mining and excavation sites. Earthmovers like bulldozers, dump trucks, motor graders, excavators, and others are the workhorses of the mining industry. They dig, push, transport, and clear waste material or the mineral of interest from the site. When these machines go down, work grinds to a halt. Due to the nature of mining itself, constant exposure to weather for long periods, heavy machines need regular ongoing maintenance. Fuel and hydraulic tanks are particularly vulnerable to deterioration. Because fuel tanks sit between the front and rear wheels, they catch rocks and impact damage from debris that chips away exterior paint and invites corrosion. Regular paint or two-part urethane coatings do not last long in these conditions and require recoating. Even rubber sheets meant to act as an impact barrier eventually fail under the onslaught of debris and moisture.

A solution was needed to provide an increased lifespan to heavy machinery to minimize maintenance and downtime. LINE-X XS-350 is a two-component pure polyurea coating that offers impact and corrosion protection to metal substrates. The tanks arrived from the mining company or maintenance contractor to the LINE-X application center for assessment and preparation for sandblasting. Generally, the fuel tanks were in poor condition and had remediation works done before arrival. Sandblasting is required to remove existing rust and provide a surface profile for a primer to be applied. Depending on client requirements, the tanks were either partially coated or fully encapsulated in XS-350. For partial coverage, the two ends and the top of the tanks were primed and painted in the required finish. Then the painted surface was re-masked before priming the remaining area with FCP, followed by the application of LINE-X XS-350.

From start to finish, the turnaround time for each fuel tank varied from 2 to 3 days. Applicators coated tanks with LINE-X XS-350 in black at a thickness of 4mm plus texture. Next, a final UV-stable topcoat completed the process so that each fuel tank had a durable outer shell to prevent impact damage and corrosion as well as UV protection to mitigate sun damage. The results have been outstanding! The durable LINE-X application resulted in repeat business from mining contractors. The LINE-X application procedure proves that fuel tanks coated in XS-350 last significantly longer in-service and reduce maintenance costs.
