INDUSTRIAL CASE STUDY

ANTI-CORROSION COATING EXPLOSIVES ARMING BOOTH & POWDER MAGAZINES

PROJECT OVERVIEW: Corrosion resistant coatings

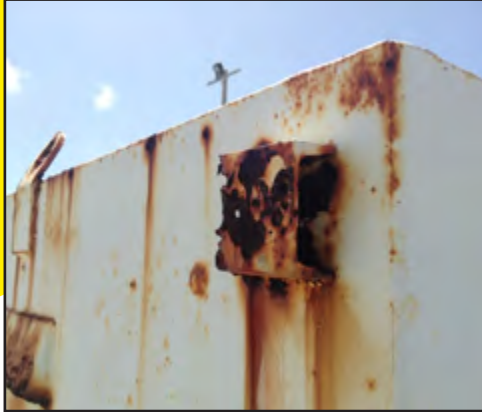
Assembly booths, where the assembly work of pipes loaded with explosives, used in oil well logs, are also shielded. The metal Magazines and the booths had a high level of corrosion that was weakening the structure. The corrosion was due to the high level of saltpetre in the environment. High levels of saltpetre are typical for locations close to the coast.

Mexican contractors, ETM, treated the areas of corrosion and sandblasted the metal substrate to provide a suitable key for applying 3mm coating of LINE-X XS-350.

Halliburton requested specific colours for each of the areas needing treating with XS-350. As requested, ETM sprayed the Powder Magazines in white, the interior of the assembly booth in black and the exterior of the booth in grey.

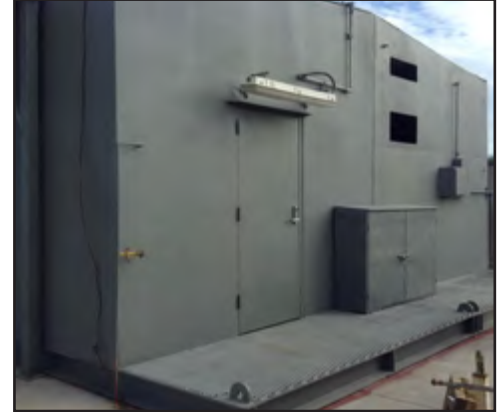
The LINE-X application has significantly improved the look of magazines and booth whilst also providing a longterm solution to prevent future corrosion and weakening of the substrate.
