INDUSTRIAL CASE STUDY

WAREHOUSE FLOORING

PROJECT OVERVIEW: Warehouse Floor For A Major International Courier Company

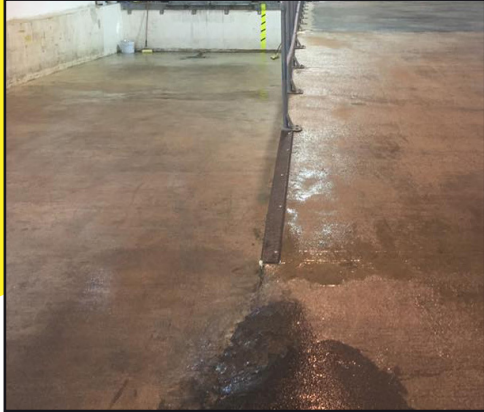
A major international courier company runs a very busy 600m² warehouse, including a truck loading bay. The concrete flooring, although only a few years old, was constantly dusting due to surface erosion caused by the constant traffic of forklift and pallet trucks.

The surface flaking and dusting caused issues on all fronts - from employee health & safety, to hygiene, continuous costly maintenance and of course a negative impact on the aesthetic front.

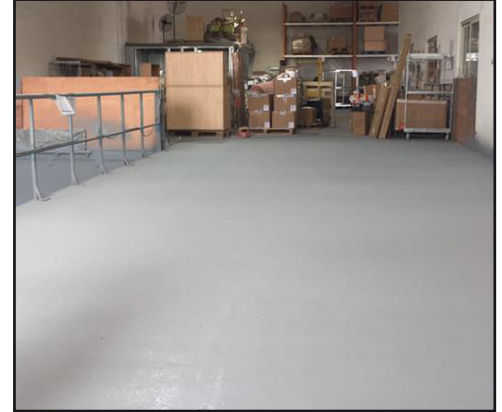
The final result was outstanding - most importantly a feeling shared by the client and employees too.

- The issues with dusting were totally resolved.
- The aesthetics of the floor improved dramatically. The warehouse transformed from a dusty garage into a clean working environment.
- Major maintenance and upkeep costs were greatly reduced, only routine floor washing/cleaning required.
