INDUSTRIAL CASE STUDY

CONCRETE WATERPROOFING

PROJECT OVERVIEW: Concrete Waterproofing - Basement Exterior Walls

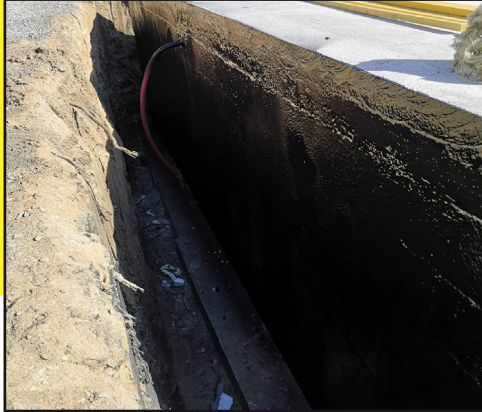
Moisture is a common problem for concrete block foundations - the moisture in the surrounding soil can cause concrete erosion and hydrostatic pressure, which can push against the foundations, causing the concrete blocks to crack.

For this application, a suitable waterproof membrane was needed to protect the concrete blocks from hydrostatic pressure, water-ingress and ground movements that deforms the structure due to temperature differences over time.

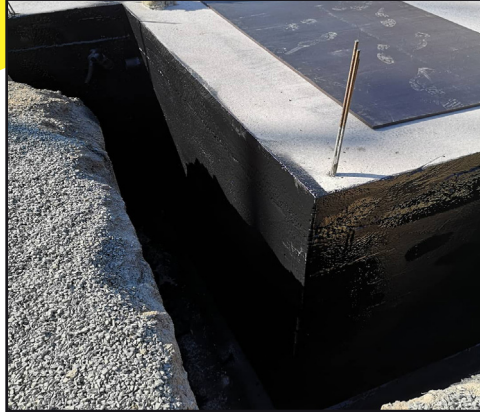
Before the LINE-X application, all dust and debris were removed from the area using an industrial vacuum. All holes were filled with a fast-setting adhesive. A combination of masking tape and special wire-trim tape were used to achieve a straight edge on the finished coating. Without using the masking tape, the wire-trim would not adhere to the concrete blocks.

Once the area was masked, a LINE-X approved concrete primer was applied to the surface. Once dry, LINE-X XS-101 was applied 2-3mm thick. After the spraying was complete, a holiday detector was used to verify the membrane was free from pinholes.

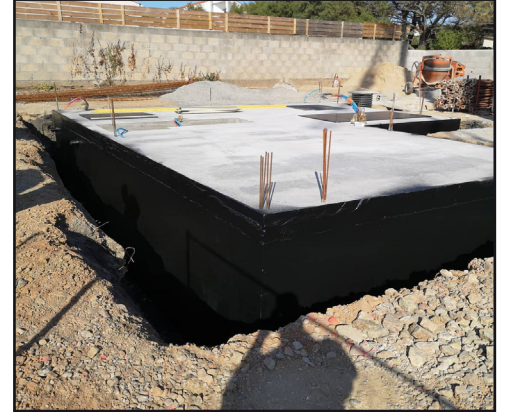
The completed application provided a durable waterproof membrane which could resist hydrostatic pressure, water-ingress and damage caused by the ground movements. LINE-X Polyurea is being requested for construction waterproofing projects due to its quick-dry times, fast return to service and longevity of the waterproofing application.
