INDUSTRIAL CASE STUDY

HEAVY EQUIPMENT FUEL TANK

PROJECT OVERVIEW: Construction/Mining/Heavy Equipment

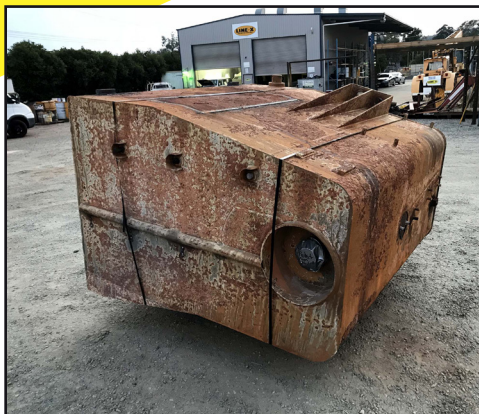
Fuel and hydraulic tanks are particularly vulnerable to deterioration. Because fuel tanks sit between the front and rear wheels, they catch rocks and impact damage from debris that chips away exterior paint and invites corrosion. Regular paint or two-part urethane coatings do not last long in these conditions and require recoating. Even rubber sheets meant to act as an impact barrier eventually fail under the onslaught of debris and moisture.
